WCRC CanSat 2022 Final Report

CANSAT MISSIONS (PROPOSALS)

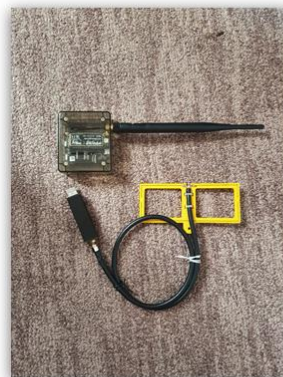
GROUND STATION

The CanSat was being monitored and controller by our ground station operators. The station consists of a laptop computer with certain apps for data flow management and radio package intake, a data logger and an antenna.
